Lección Aprendida de Incidentes de Descontaminación- Problema y Desafíos

Health
Facilities
Scotland

**Un Ejemplo
de
Investigación**

Super-Slide Laminectomy Retractor

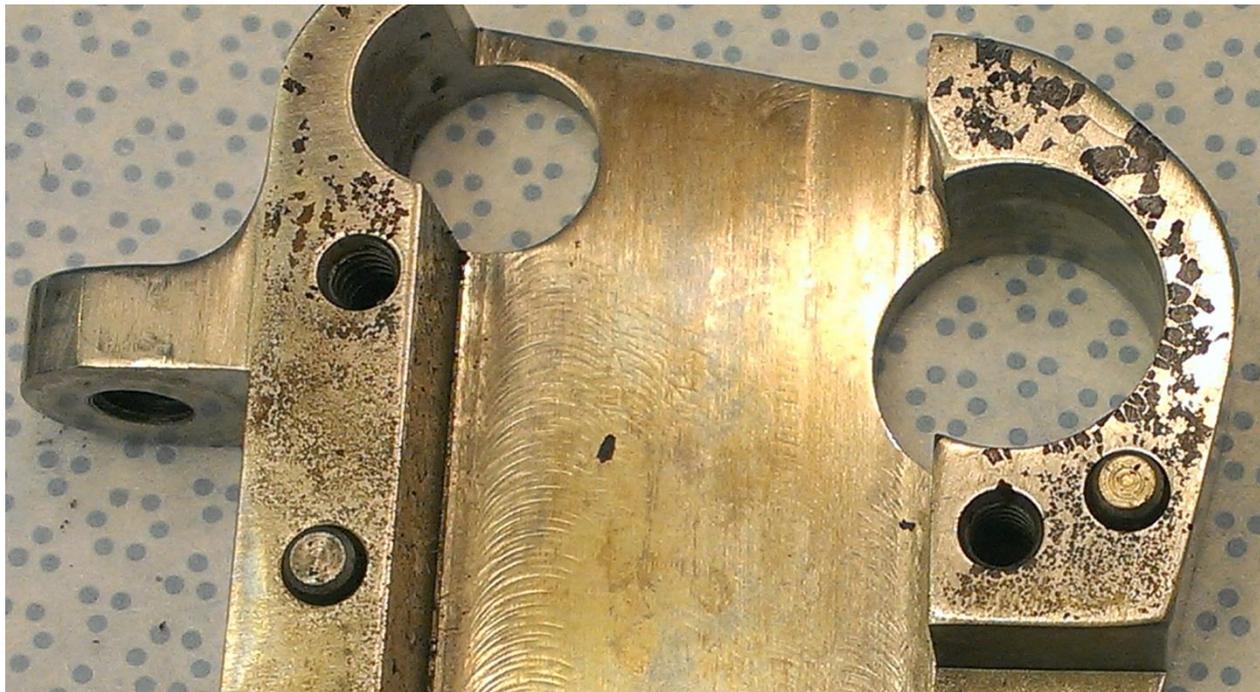
Inspección 8 Oct 2013

13 usos después de
servicios

IDU (Ene 2013)

Contaminantes
detectados

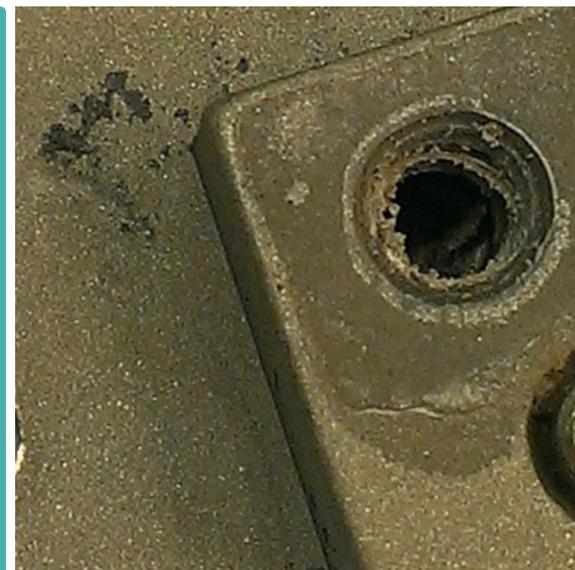
Resultados de la prueba de proteína

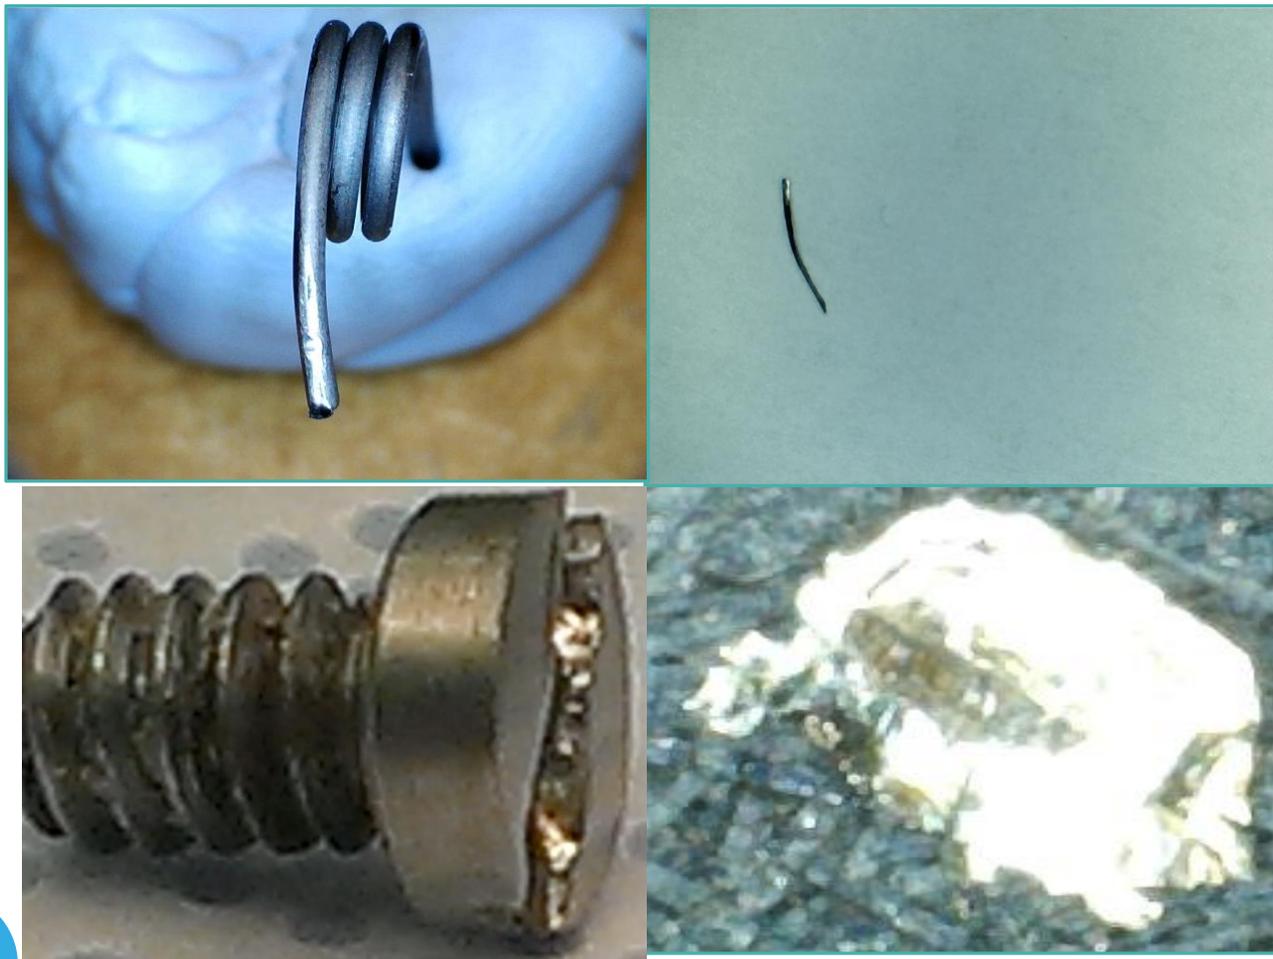
Hallazgos: Daños y Fragmentación de Componentes
