Duodenoscope Reprocessing and Verification of Interdependencies in Clinical Settings

Name: Rittich

Affiliation: Olympus Europa SE

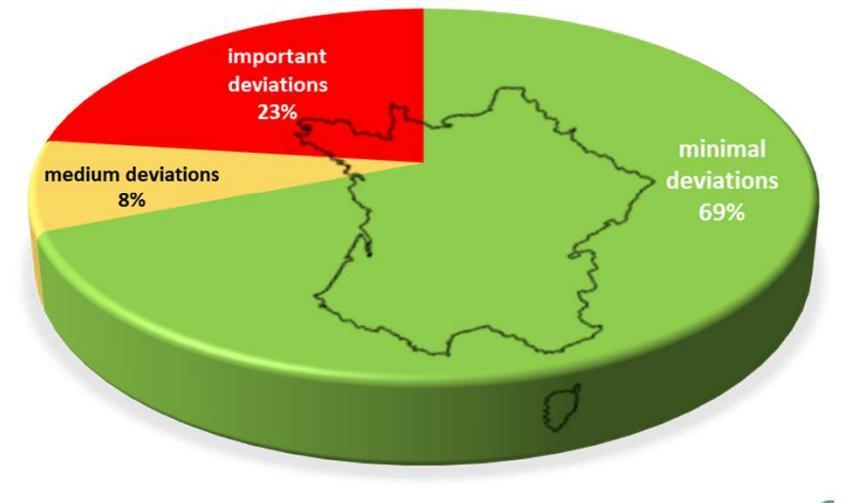
#### **Initial observation**

31% of all hospitals displayed medium to importantdeviations from the reprocessing protocol upon the initial visit

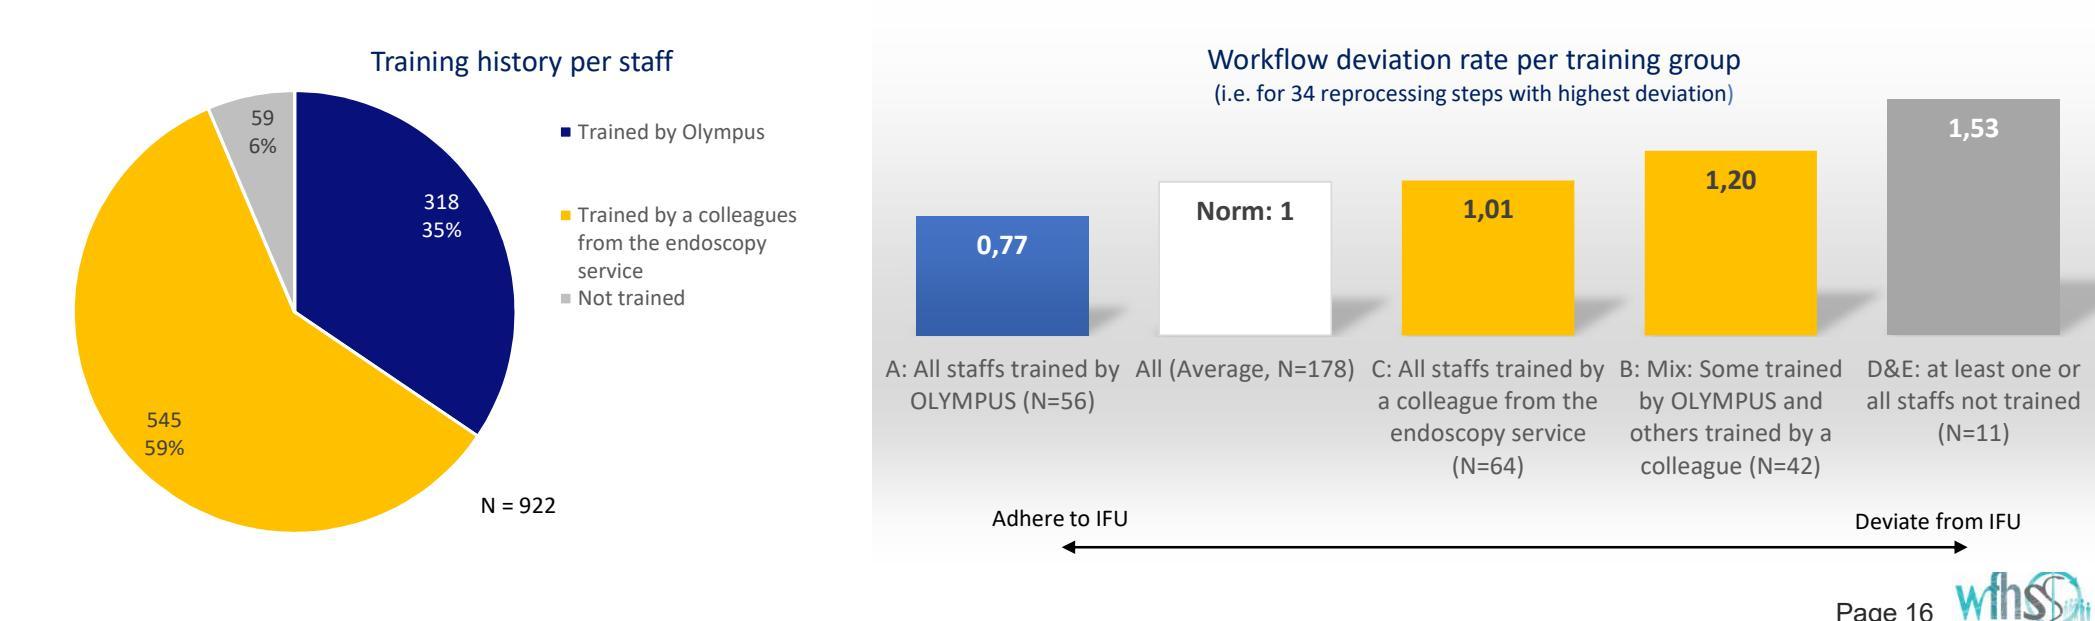
#### Key findings: Staff qualification by the manufacturer is key to ensure adherence to IFU

- Appr. 35% staffs were exclusively trained by Olympus (both per hospital and per staff)
- 44% hospitals (= 59% of staff) did not undergo direct training by Olympus
- Users trained by manufacturer showed closer adherence to IFU than others

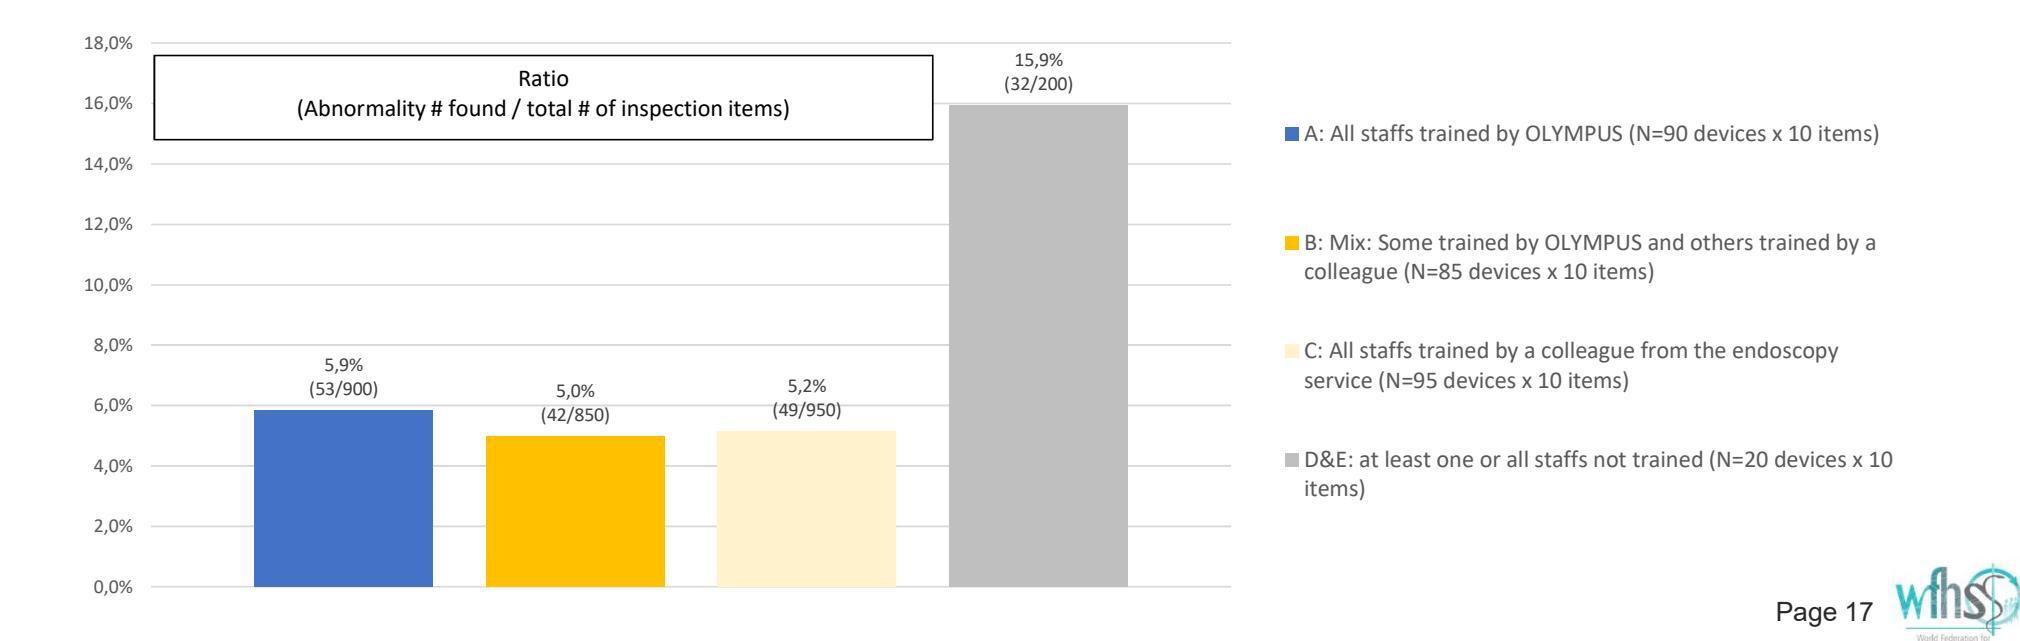
#### Key Findings: Lack of staff qualification seems to result in higher damage rates

- No distinct difference among Group A, B, and C.
- Device handled by group D&E (not trained) indicate higher abnormality rate, although a small number of data (N=20)

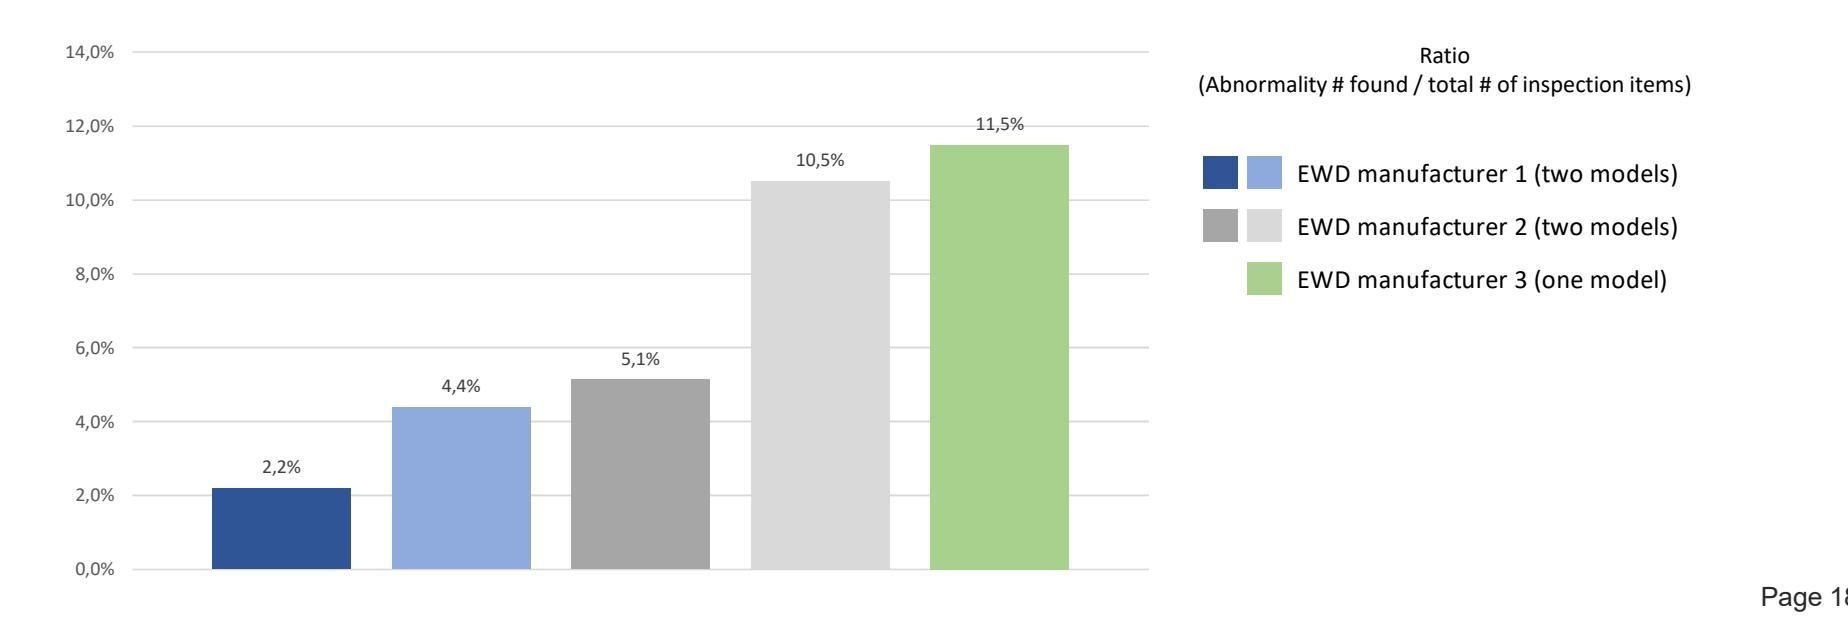
**Key findings:** Observed irregularities on endoscopes seem to correlate with use of **Endoscope Washer Disinfectors (EWD)**

- Occurrence of damages seems to be related to EWD models and / or process chemistry used
- Findings increase with increased PAA concentration of process chemistry / pH value during reprocessing
