Contamination and surface damage on reprocessed robotic system surgical instruments in clinical use

#### **PRELIMINARY STUDY**

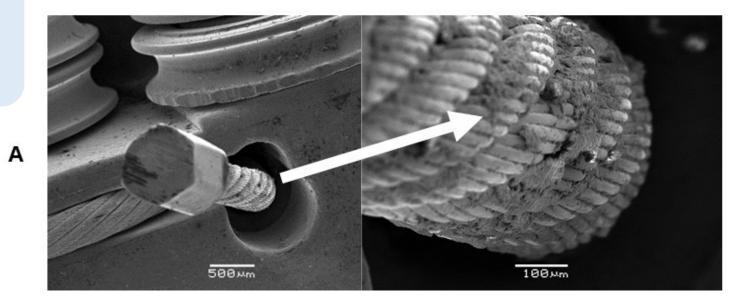
Monopolar Curved Scissors → Joint cable

Figure 1. Scanning electron microscopy images of robotic system surgical instruments in clinical use after reprocessing. A - Debris on the wire of a surgical instrument joint.

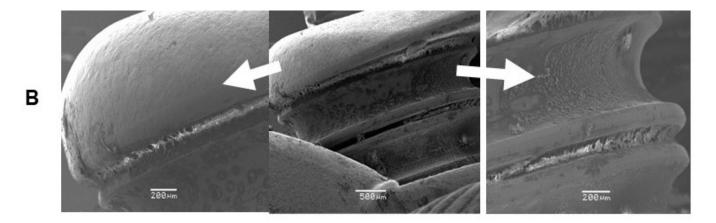
Monopolar Curved Scissors → Pulley after cables removed

**Figure 1.** Scanning electron microscopy images of robotic system surgical instruments in clinical use after reprocessing.

B – Debris on the pulley of a surgical instrument joint.

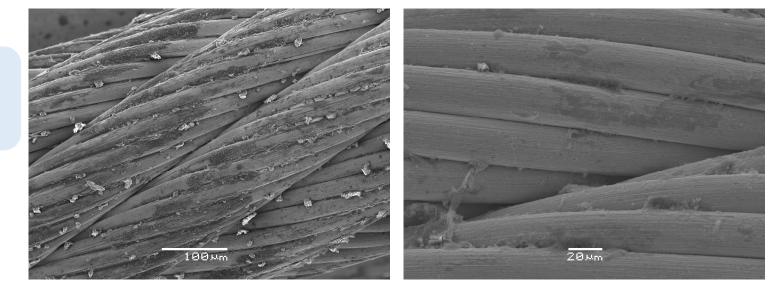
Monopolar Curved Scissors

Large Needle Driver

#### Joint cables/wires

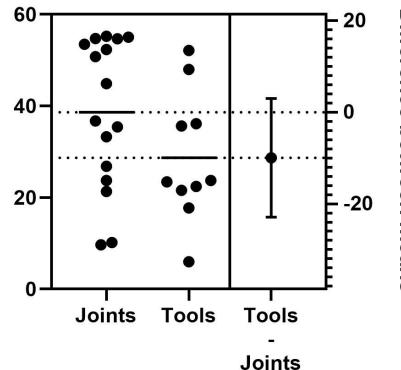
#### **Estimation Plot**

• Average <u>33 μg/cm<sup>2</sup></u> (range 6 μg/cm<sup>2</sup> to 55 μg/cm<sup>2</sup>)

**10-fold**  $\rightarrow$  "alert level"  $\geq$  3 µg/cm<sup>2</sup> **5-fold**  $\rightarrow$  "action level"  $\geq$  6.4µg/cm<sup>2</sup>

Difference between means

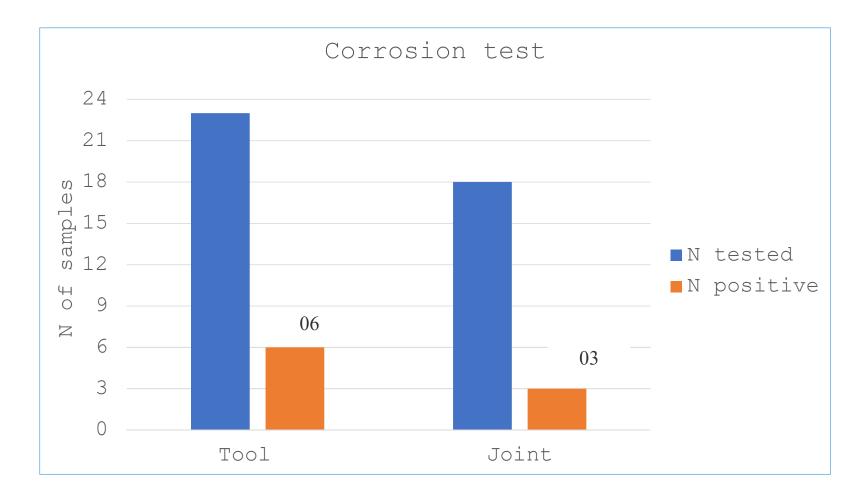
# Results $\rightarrow$ corrosion

→Robotic System Surgical Instruments (RSSI) in clinical use (10th) contaminated with organic matter (protein) + surface damage (corrosion).
