25th wfhss CONGRESS

20-23
NOV 2024
SANTIAGO-CHILE

Identification and prevention of surface alterations on surgical Instruments caused by waterborne minerals

- **Name:** Dr. Matthias Tschoerner
- **Affiliation:** Chemische Fabrik
Dr. Weigert GmbH & Co. KG
Hamburg (Germany)

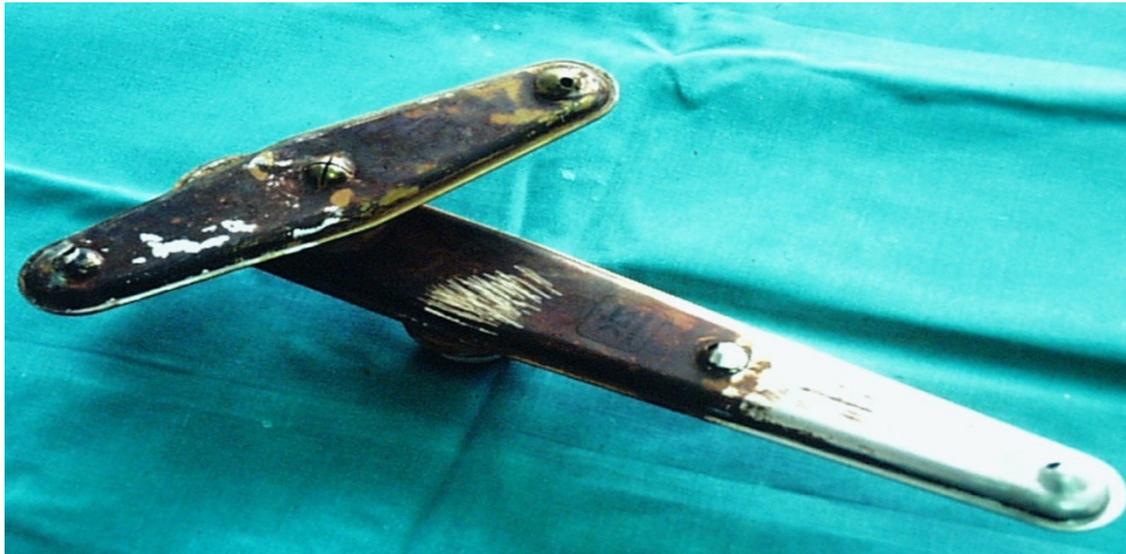
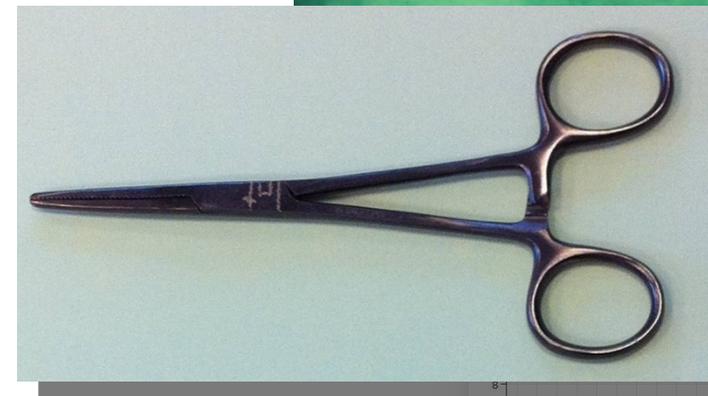
Heavy and non-ferrous metals

(Iron, Manganese, Copper):

Dark discolorations and deposits, inactivation of water softener

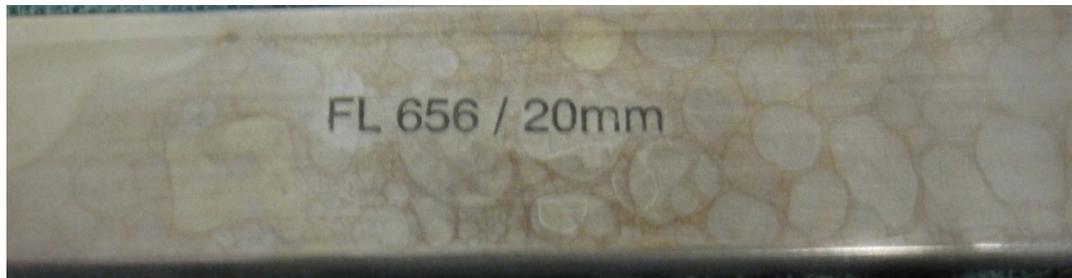
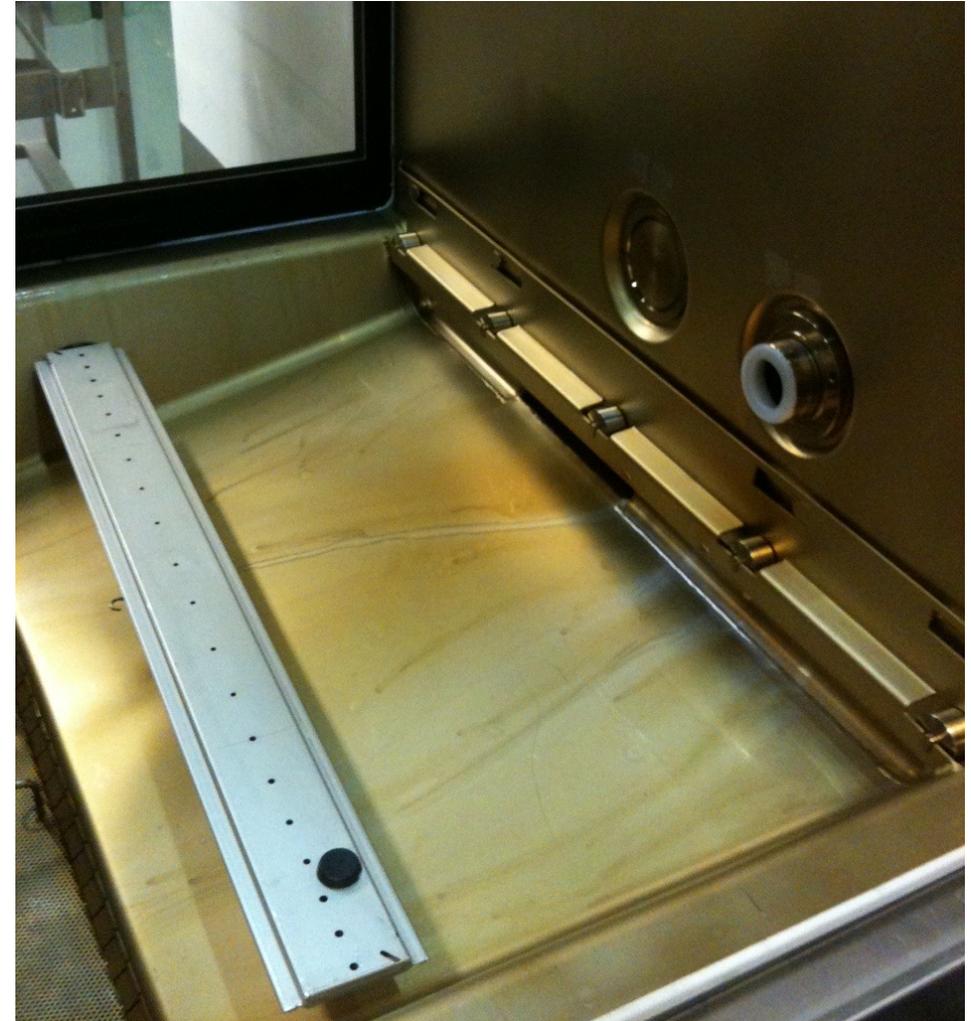
Silicic acid/ silicates

Stubborn yellowish-brown or bluish-violet glaze-like deposits

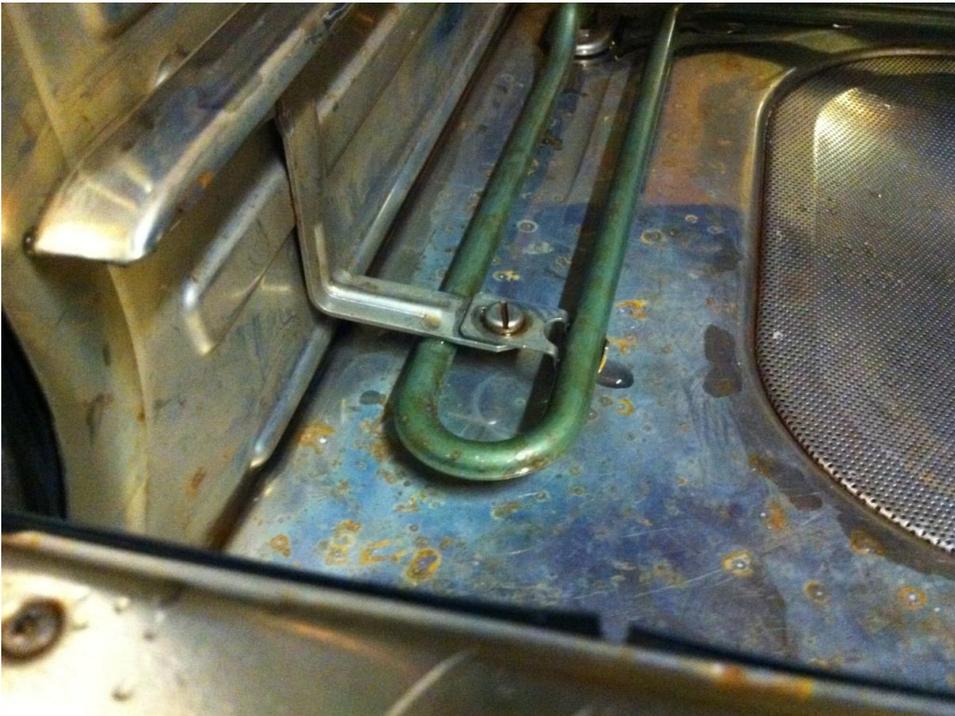
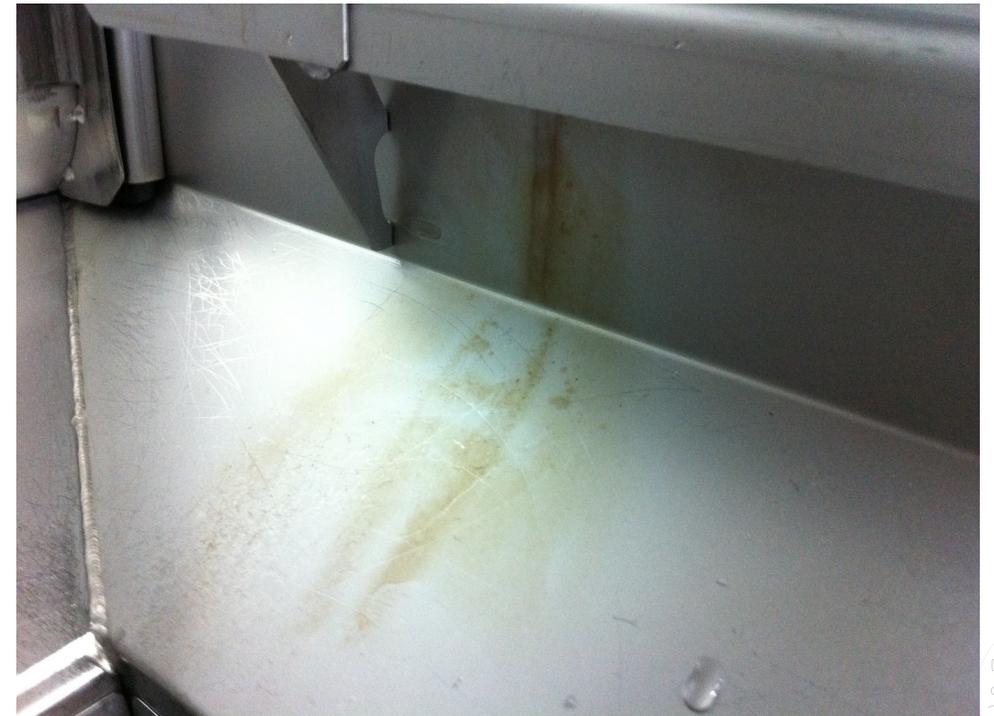
Chloride

Chloride induced pitting corrosion

Rust particle

Rust transfer

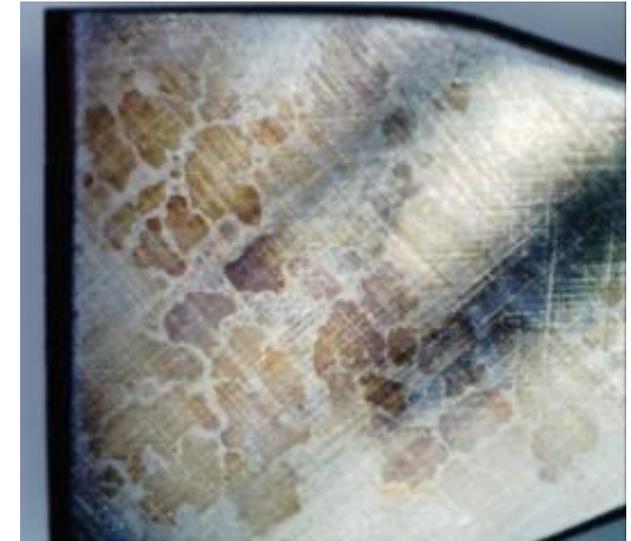
SEM-EDX, Scanning Electron Microscopy with Energy Dispersive X-ray Spectroscopy

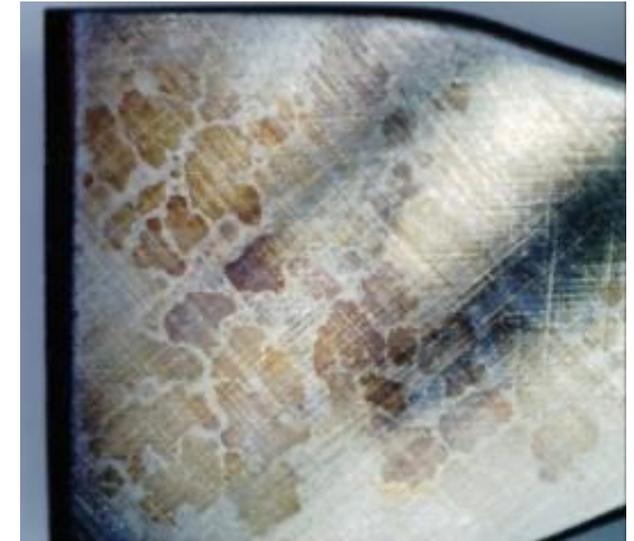
ESCA / XPS – Electron scattering for Chemical Analysis / X-ray Photoelectron Spectroscopy

- Information depth 1 – 10 nm
- Si E_b 102,8 eV → chemical shift specific for bonding state: SiO₂
- Depth profiling by sputtering with Ar → layer thickness approx. 10 nm

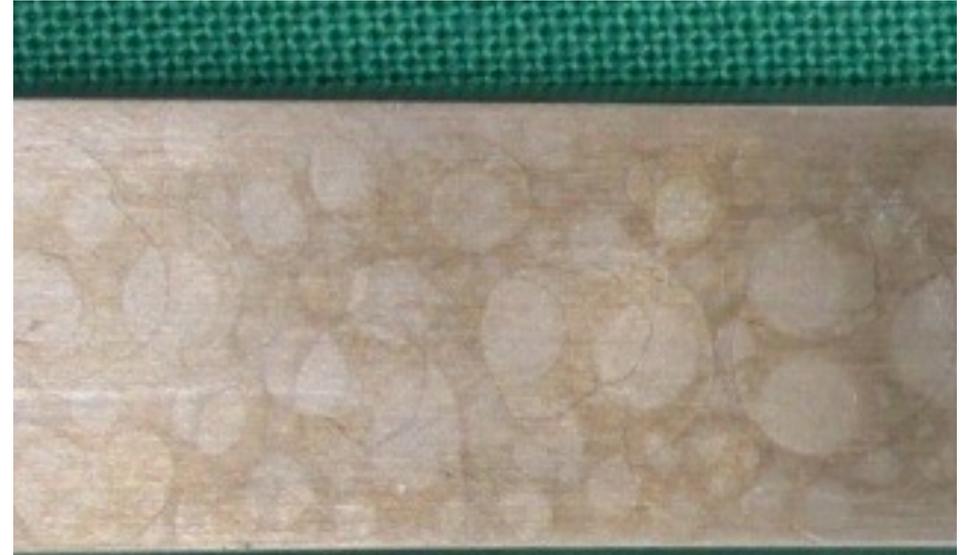
Osteotom, EDX

Element analysis	C	O	Si	Cr	Fe
Instrument material	8,23	2,91	0,41	13,7	73,2
Discolored Surface	4,49	0,86	0,37	14,4	79,9

EDX-Analyse Fa. Aesculap - Probe TM

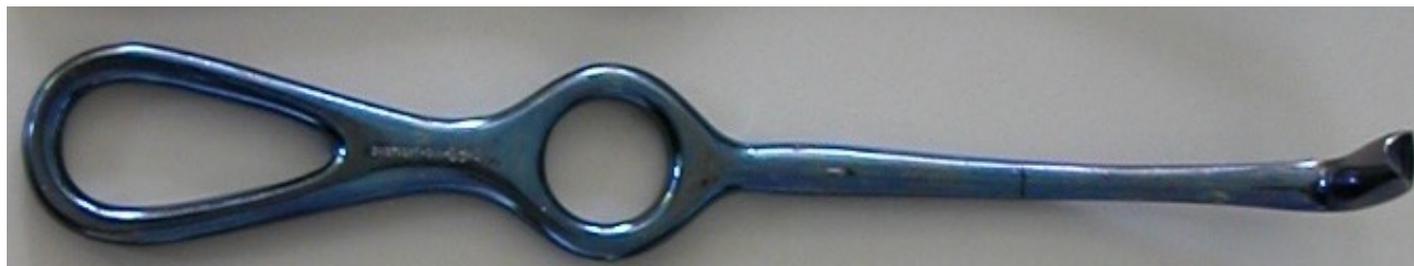
Wound hook blue, EDX and XPS

Element analysis	C	O	Si	Ti	Cr	Fe
Instrument material	2,02		0,58	0,37	13,7	83,3
Discolored Surface	0,9	1,59	0,22	1,24	8,35	86,9

Element analysis	C	O	Si	Ti	Cr	Fe
Discolored Surface	76	17,3	0,6	1,5	0,3	0,7
Discolored Surface, 4 min sputtered	17	46,9	-	13,8	1,9	18,8

EDX-Analyse Fa. Aesculap - Probe WH Blau

XPS-Analyse Dr. Weigert - Probe: 89668A

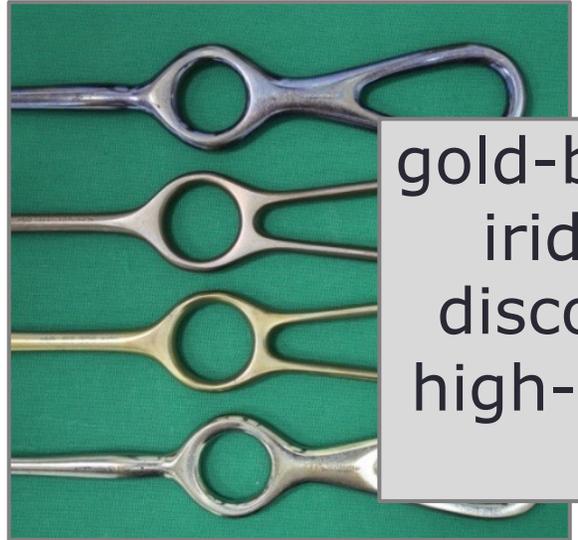
gold-brown to blue-violet, iridescent, uniformly discoloration of smooth high-gloss stainless steel surfaces

Titanium oxide layers (ca. 10 nm)

caused by traces of titanium minerals in silicate-containing cleaners

- The discolorations are caused by a few nm thin titanium oxide layers and silicate layers.
- After mechanical stressing, no changes in the surface structure was observed for all characterized linings. No disruption or detachment was observed with SEM.
- Due to mechanical stress, no particles of SEM detectable size were separated from the test instruments.
- The investigated deposits show no cytotoxic properties.

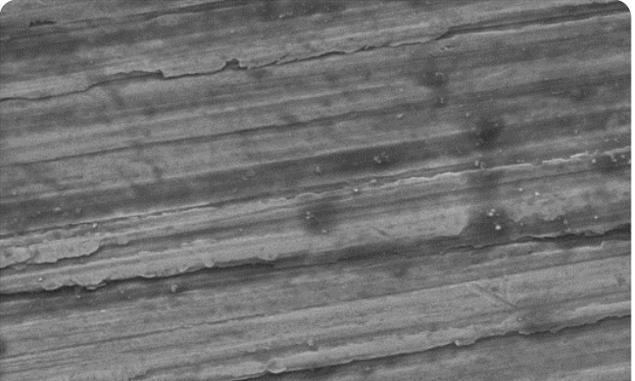
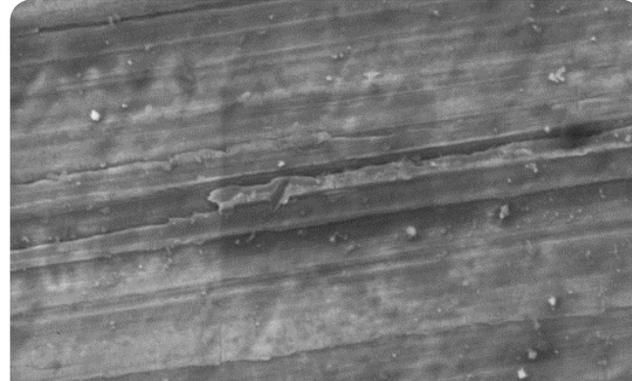
Bending test in the area of elastic and plastic deformation with SEM imaging before and after the test (SEM, resolution < 2 μm)

<p>Start</p>	<p>Bending 2 mm Elastic deformation</p>	<p>Bending 4 mm Plastic deformation</p>
<p>Picture A (start condition)</p>	<p>Picture B1 (elastic deformation)</p>	<p>Picture B2 (plastic deformation)</p>

<p>2 μm EHT = 10.00 kV Mag = 5.00 K X Date :23 Jul 2015 Signal A = SE1 WD = 10.0 mm BRAUN SHARING EXPERTISE</p>
