HONG KONG
ASIAWORLD-EXPO
亞洲國際博覽館

Hong Kong Experience in Control of Wet Pack through Scientific Approach

Name: Teddy LEE (teddy@hkssma.org)

Affiliation: Vice Chairman, HKSSMA

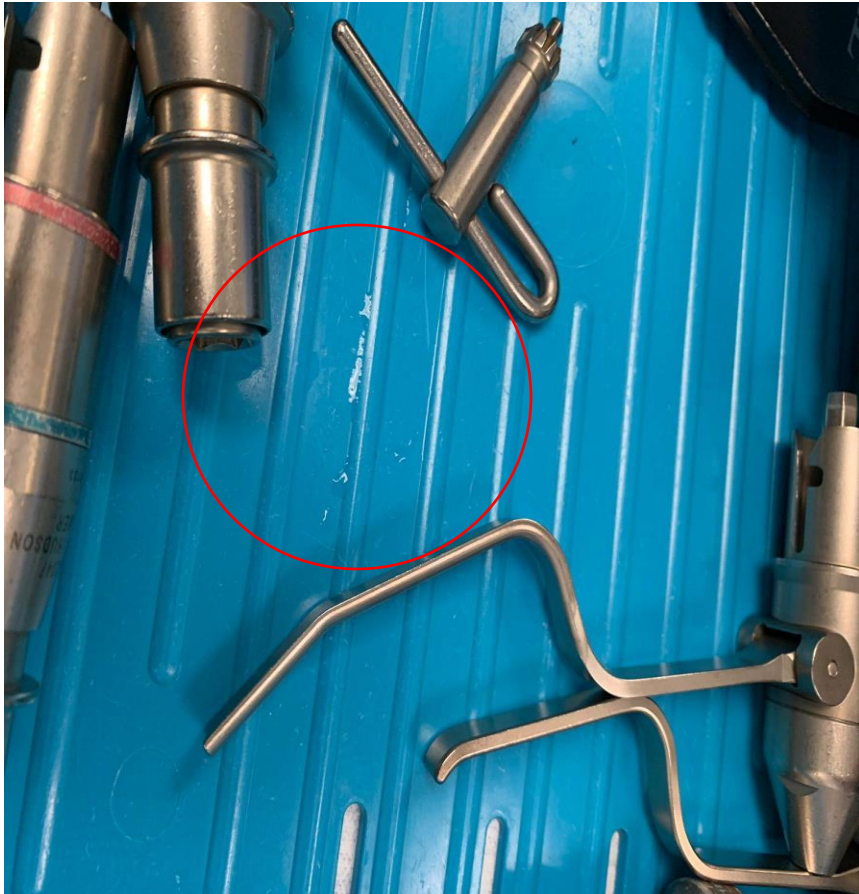
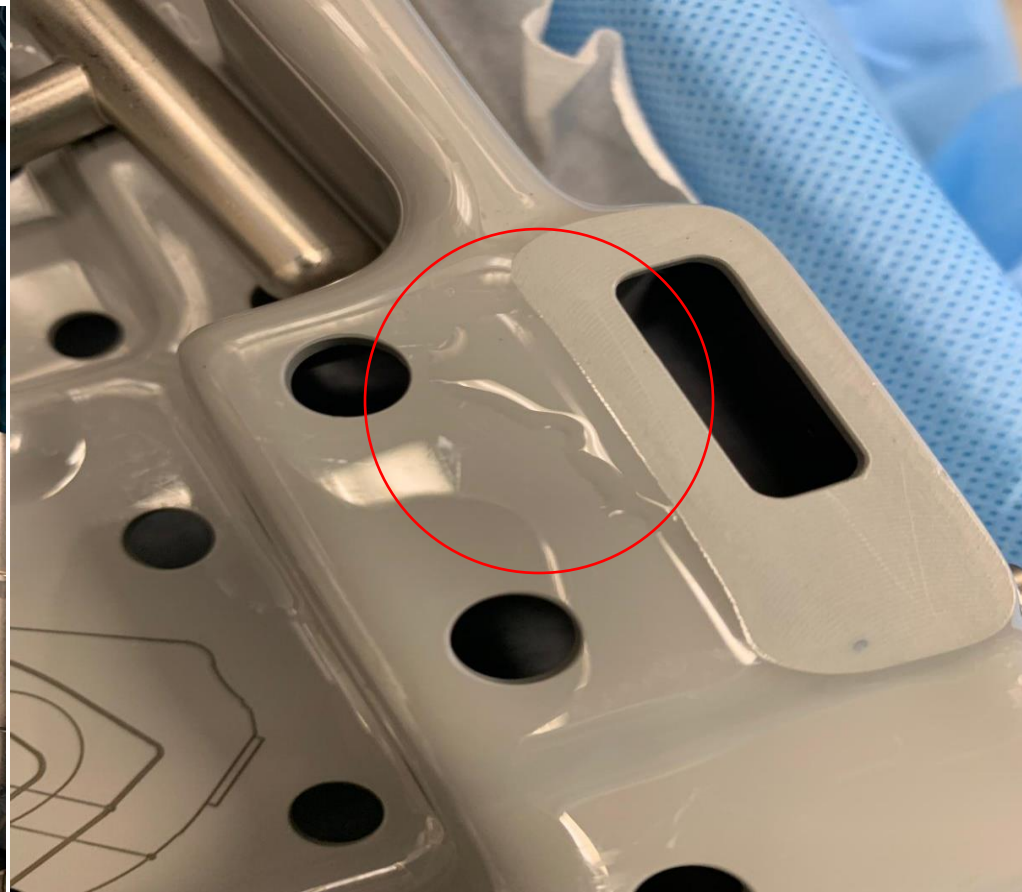
Conservation of Heat Energy for Drying

Plastic bottom have little heat energy to convert condensate to steam

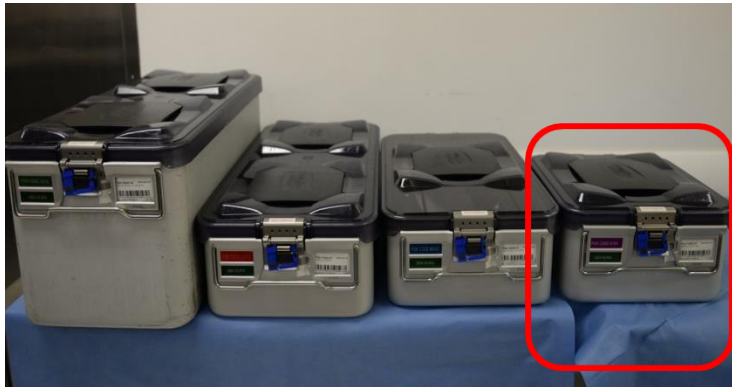
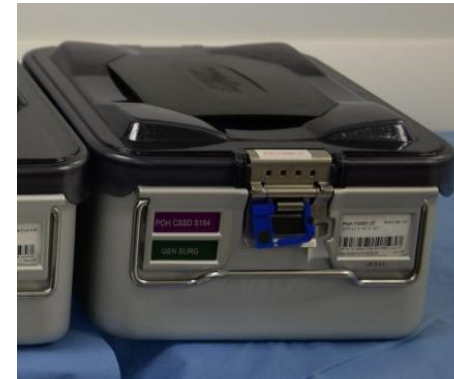
Smallest size container

- **Size:** 254mm x 258mm x 75mm
- **Volume** = 4914.9 cm³
- **Condensate change to steam volume ratio** is 1:1690 at 1 bar = 100 °C
- **Assume all condensate vaporized.** 4914.9 cm³ / 1694 = 2.9 cm³ condensate

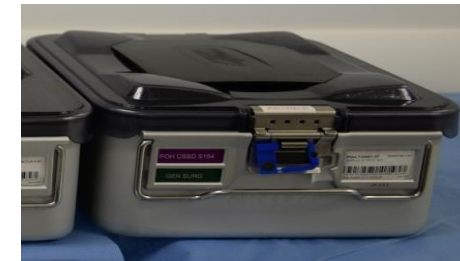
Smallest size container (shown as image)

- **Condensate change to steam volume ratio is 1:7650 at 60°C**
- **Assume all condensate vaporized. $4914.9 \text{ cm}^3 / 7650 = 0.64 \text{ cm}^3$ condensate**
- **At 100 °C with 2.9 cm³ condensate = 97% - 100% relative humidity**
- **At 60°C with 0.64 cm³ condensate = $0.64 / 2.9 = 22\%$ relative humidity. Consideration should be calculated relative humidity of the filter air for balancing the pressure at the end of the sterilization cycle.**

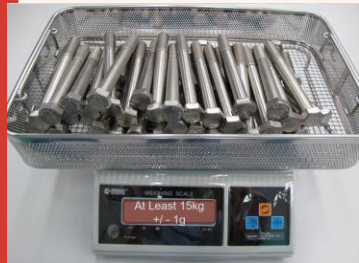
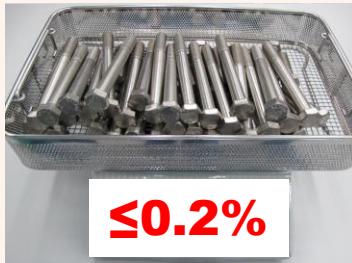
3)Load Dryness Test

$$\Delta m = \frac{(m_2 - m_1)}{m_1} \times 100\%$$

Weight Comparison

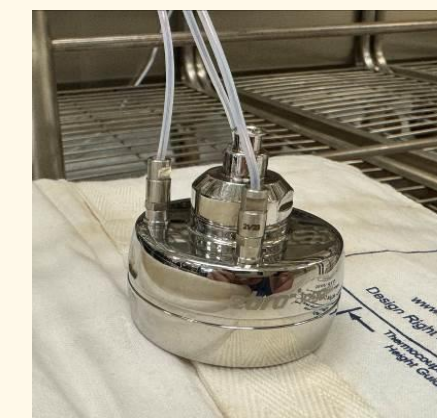
5. Vacuum Pressure Performance

Compare the vacuum pressure for assuring the efficacy of pump

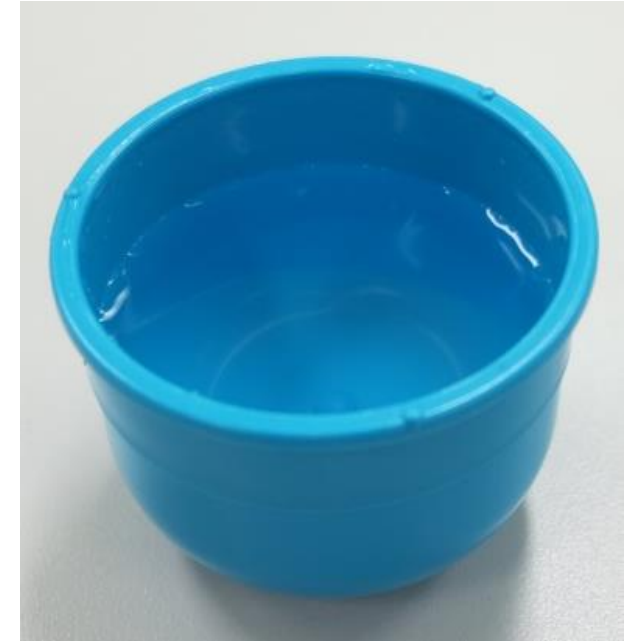
Test performed in CSSD Tuen Mun Hospital

- 1 gallipot of sterile water (less than 50 ml) were randomly poured on to the instrument to simulate an **extreme situation / the worst case**.
- The tested item sets were undergone normal steam sterilization cycle

➤ Before Sterilization

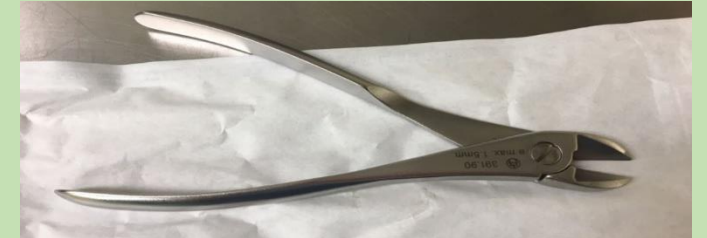
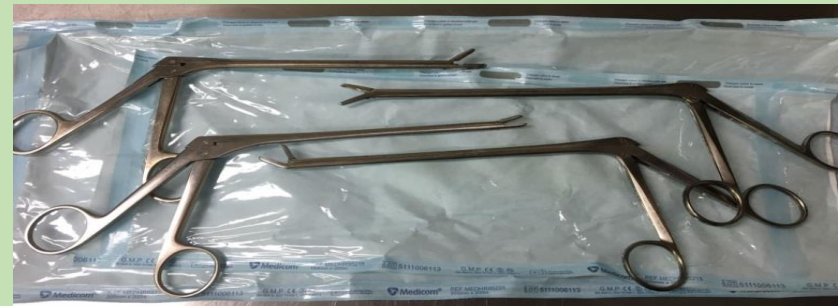
➤ After Sterilization
